FISHERY PROGRAMS ANNUAL REPORT 2022

SALMON COUNTING FENCE ANNUAL REPORT 2022

Little River Water Quality Assessment 2022

LITTLE RIVER BRAVER DAM REMOVAL PROJECT 2022

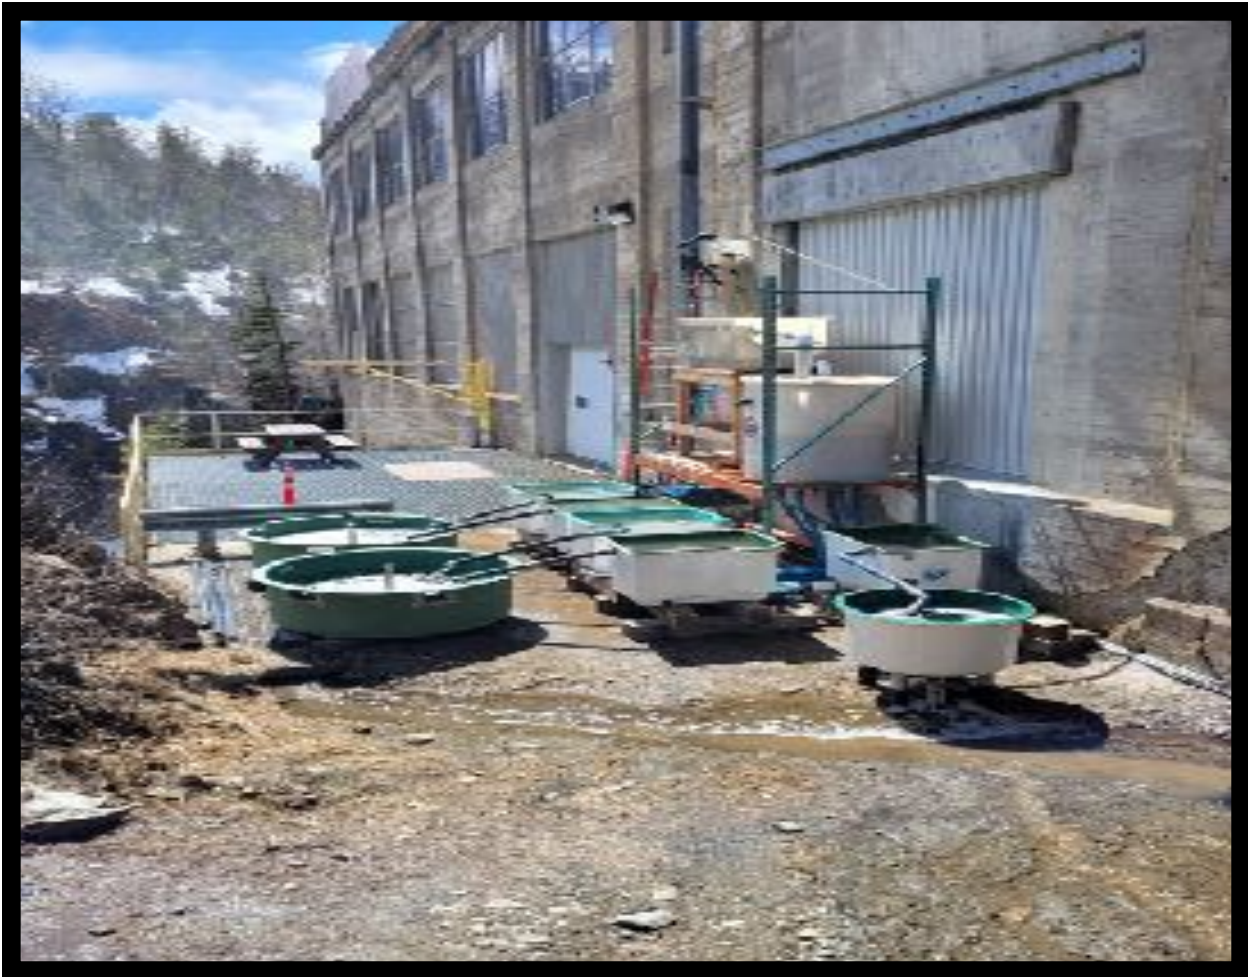
Typical Incubation layout

The stream side incubation system was installed on April 22nd. at the Nepisiguit NB Power Dam facilities. Four [4] incubation boxes with a head tank and 2 circular tank and degassing tower were installed including a parabolic filter. All hoses, valves and tanks were refurbished in 2020 with new fittings and valves to facilitate installation and better control of water management, disinfected and operational for the expected eyed eggs that was delivered on April 27th.

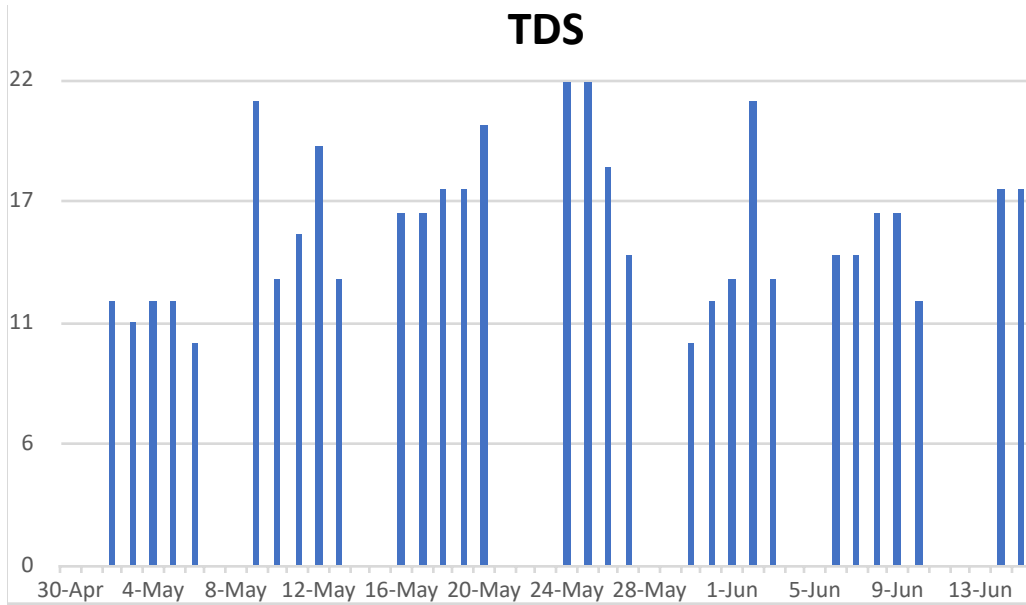
Over the last two years development of camps on the Nepisiguit River have been erected, these building are built on the edge of the embankment. Excessive sedimentation has been observed in the river, from loose debris and erosion from the building sites in the river. The following graph indicates the TDS (Total dissolved solids) data during that period.

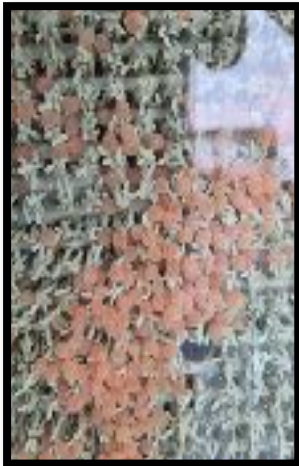
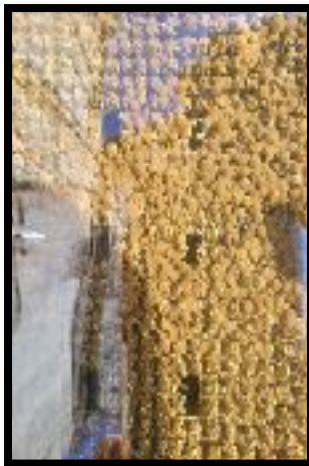
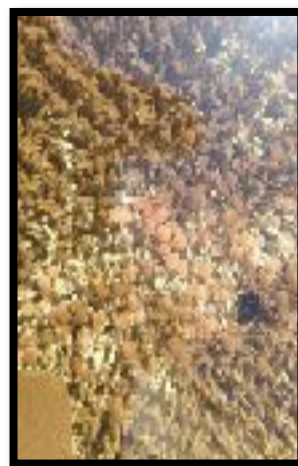
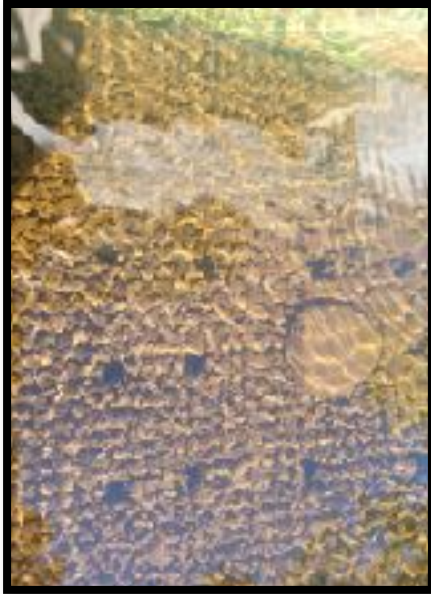
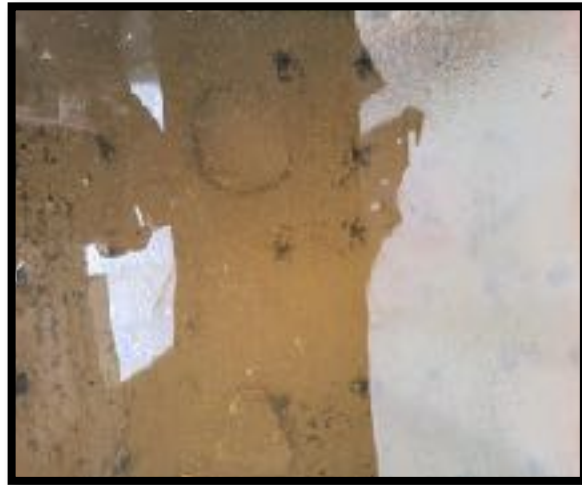
- The following picture timeline demonstrate sedimentation progression.

April 27th Salmon egg delivery day

May 3rd, 2022

May 10th 2022

May 20th 2022

May 27th 2022

In our case, we never had this issue over the years as we have added to our systems a parabolic filter to prevent and reduce sedimentation.

This year we had to clean this filter every day 7 days a week including lower units the incubation tanks.

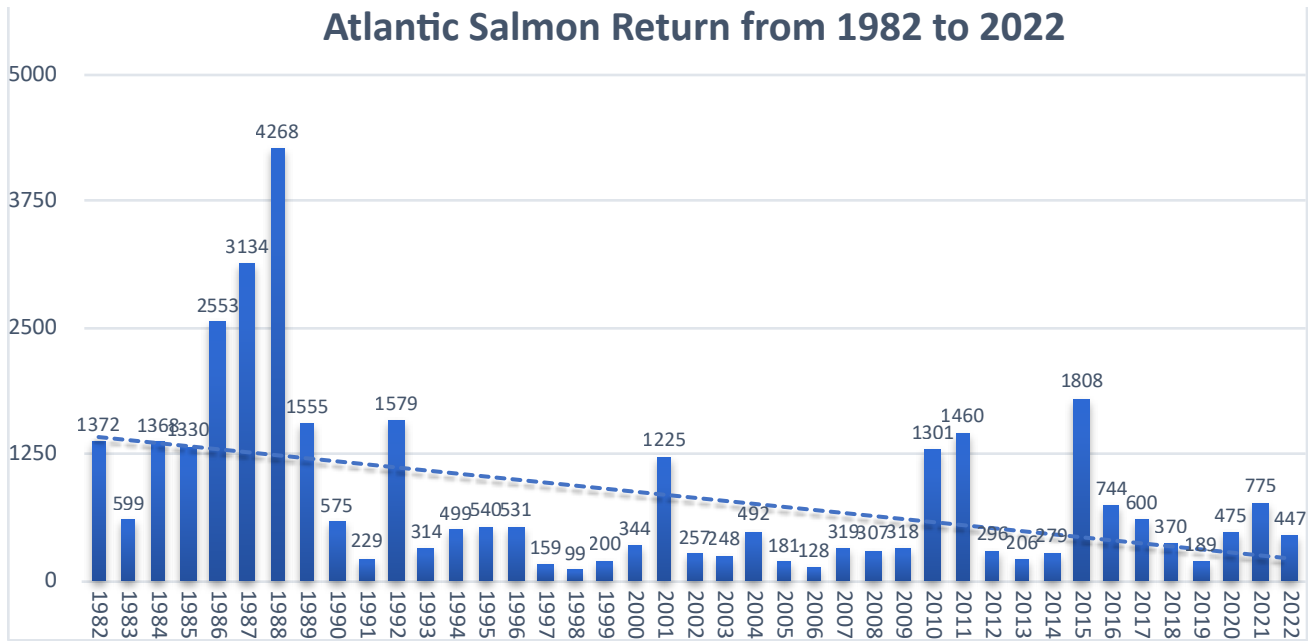
The graph indicated below, demonstrates Atlantic salmon return on the Nepisiguit River.

The blue dotted line indicates a trend that is very concerning to the returns of Atlantic salmon on the Nepisiguit River. With additional factors challenging this issue can usually be resolved by increased stocking, and efficiently stocking in key areas to better increase the survival rate of the Atlantic salmon fry distribution. Also increasing the spawning yield in respect of the trending Atlantic salmon return.

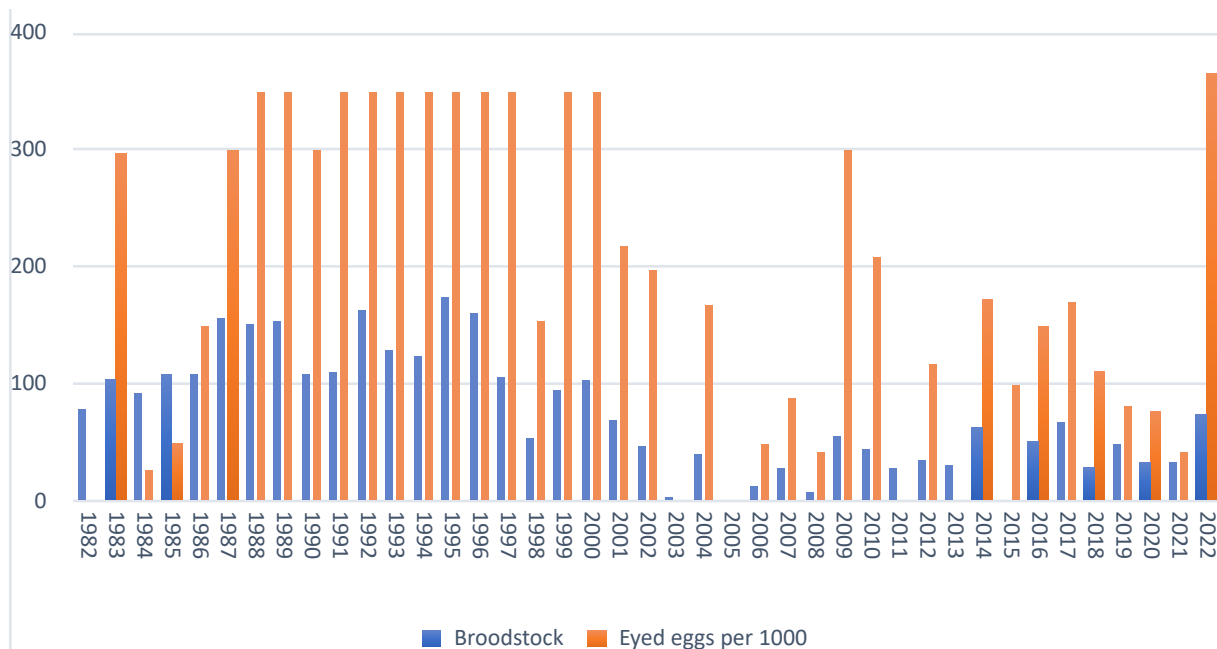
Total Broodstock used vs Total eyed egg yeild

The next graph below indicates the brood stock vs eyed egg yield over the years. (Indicated in green are the green eggs yielded in 2022)

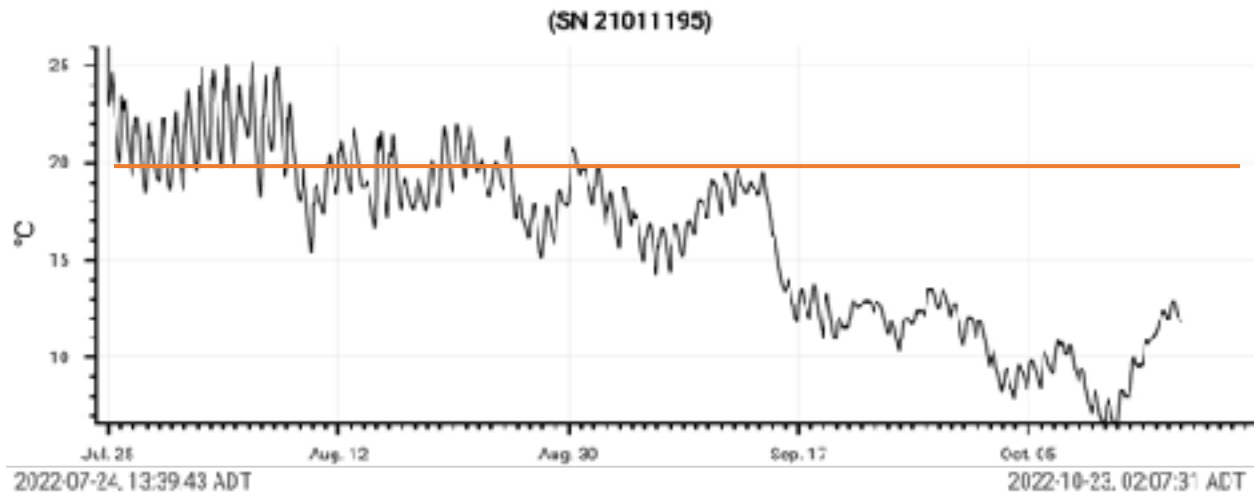
Figure 2 – NB-13 location

In addition to water temperature readings, 3 - HOBO™ thermal data loggers have been installed on June 1st to late October in 3 strategic locations on NB-13 (**Figure 2**), SB-1 (**Figure 3**) and LR-9 (**Figure 4**). Note that the data logger on NB-13 was missing during the period of June 1st. until replaced on July 25th.

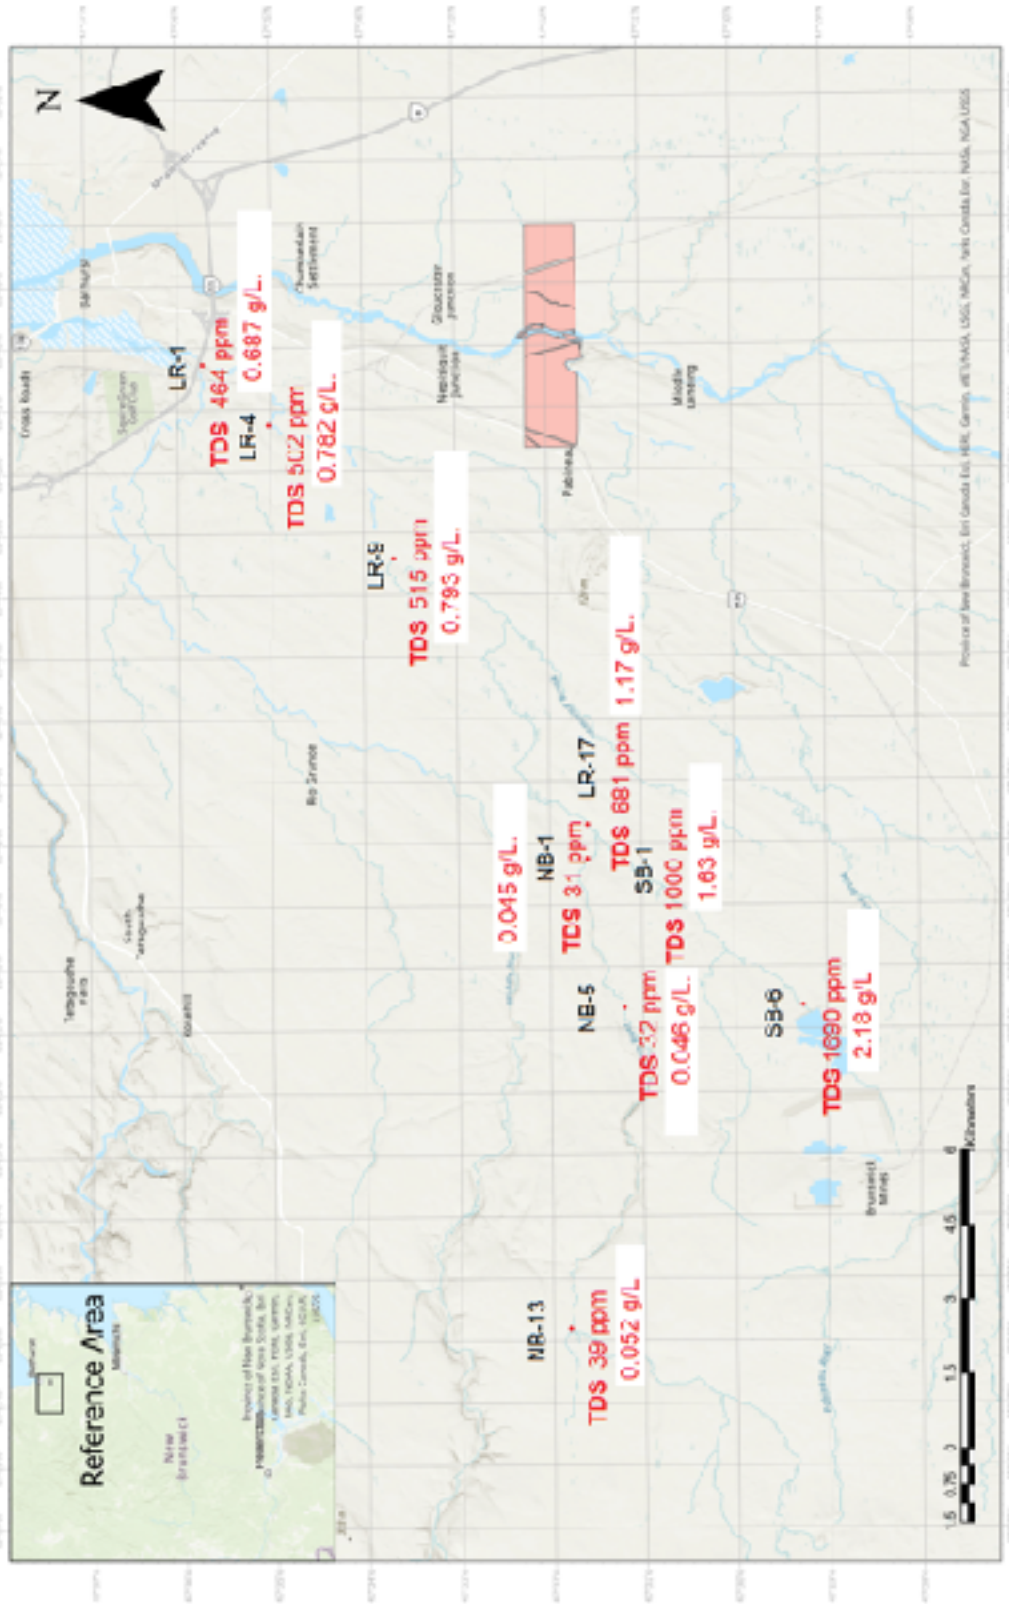
Figure 5 – July 2th TDS Readings

The following charts **Figure 5** July 20th and **Figure 6** September 7th indicate the fluxuation of TDS (total dissolved solid) observed over the season, this reflect the variation of data recorded.

TDS Readings Little River - July 20th

It has been observed during the maintenance activities from the former Brunswick Mine #12 area water treatment plant that flows into the South branch of the Little River.

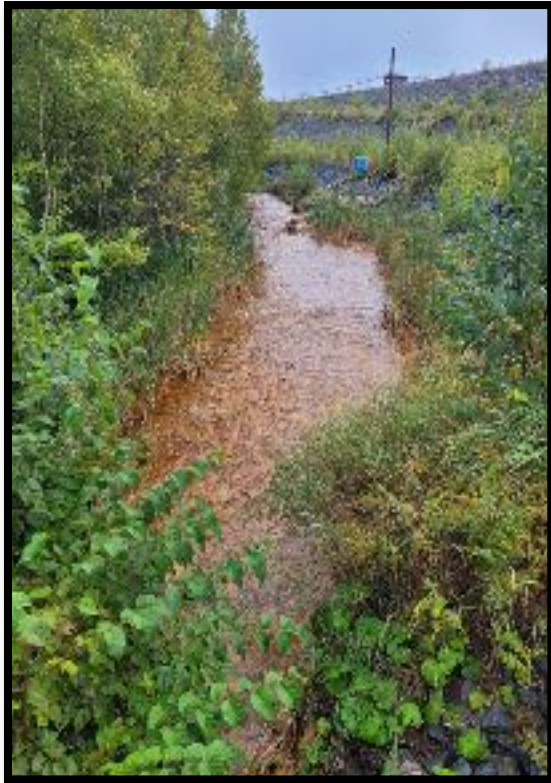
Photo 1 - SB-6 Location

Indicated below in **Photo 1** and **Photo 2** is the variance of water flow and water depth at the SB-6 station.

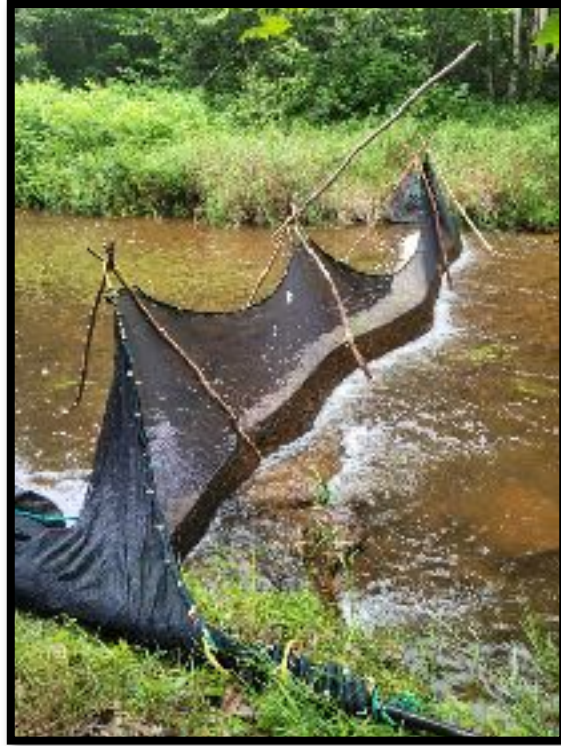
Heavy sedimentation is observed in the South Branch of the Little River, during electrofishing activities. Shown on **Photo – 3** is the accumulation of sedimentation on the net for fish capture of electrofishing session on site SB-1, of only 30 minutes of installation.

Photo 3- SB-1 Location, note the high water upstream due to sedimentation blocking the catch net.

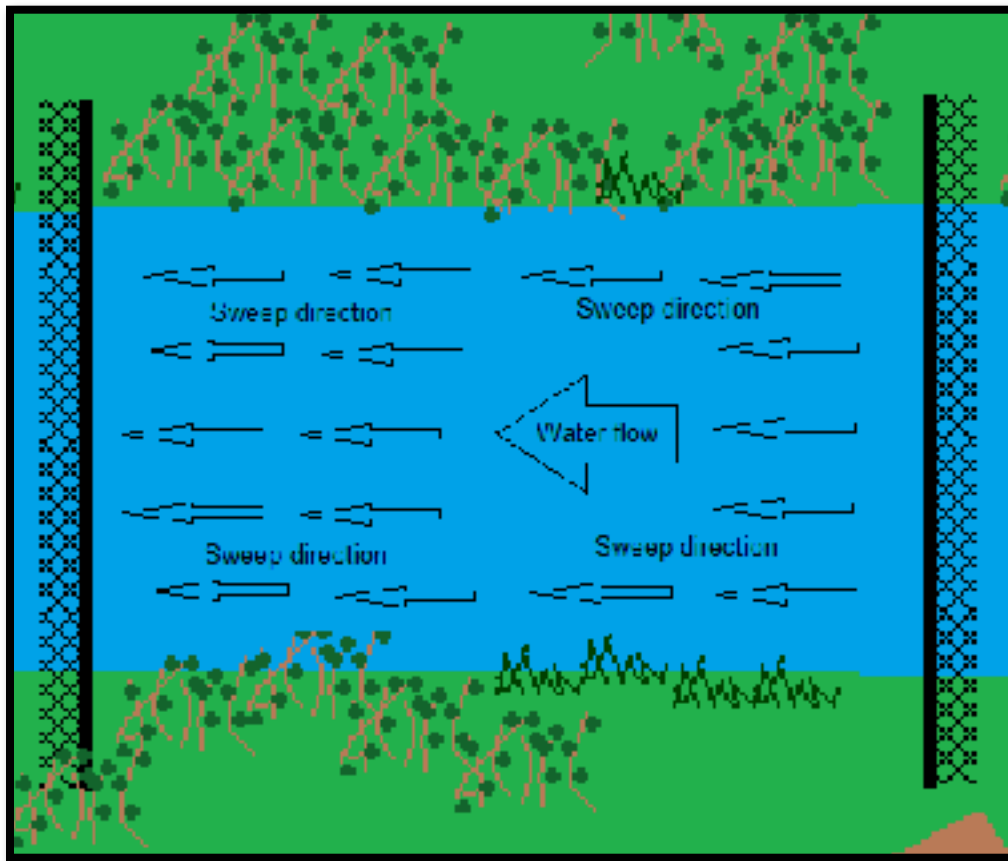
Figure 2

Electrofishing begins at the bottom barrier working from one side of the river to the other side following the downstream net (**Figure 2**). First the person with the back pack always sweeps with the water direction starting upstream towards the bottom barrier net. One person should be walking with the dip net downstream of the wearer of the back pack to collect the stunned fish that either floats in the water or have been held against the bottom barrier net. The two person team with the apron net should follow behind until the entire bottom barrier net has been cleared.

Typical sweep direction into net

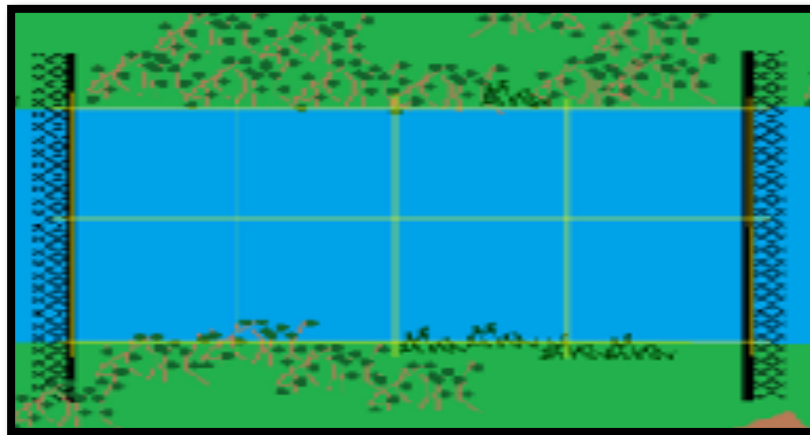
Figure 3

There are other parameters observed during electrofishing studies. Such parameters are water depth measurements. 20 measurements are recorded within the electrofishing site after the three sweeps have been completed and the fish are all measured. Total lengths are taken three times, one on each side and one in the center (**Figure 3**). Total widths are also measured five times dividing the site in equal parts. These lengths and widths are added to the field sheets which are later used to determine the total dimension of the electrofishing site in square meters.

Typical measuring grid

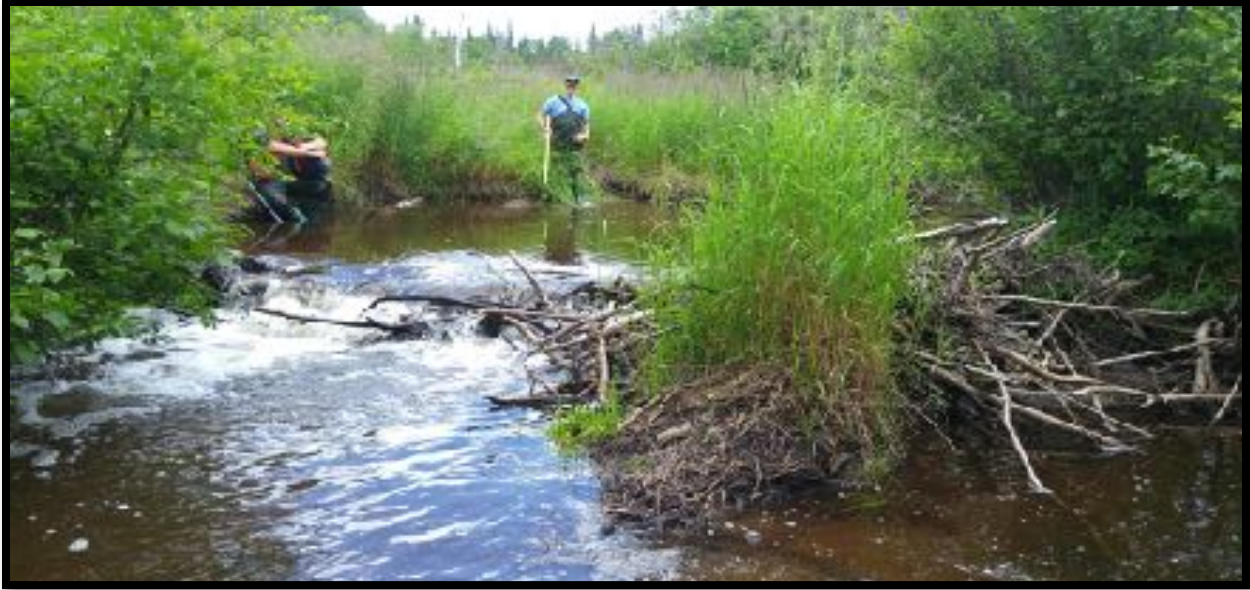
Dam site # 1 removed

Water level above dam: 13 inches

Water level below dam: 3.5 inches

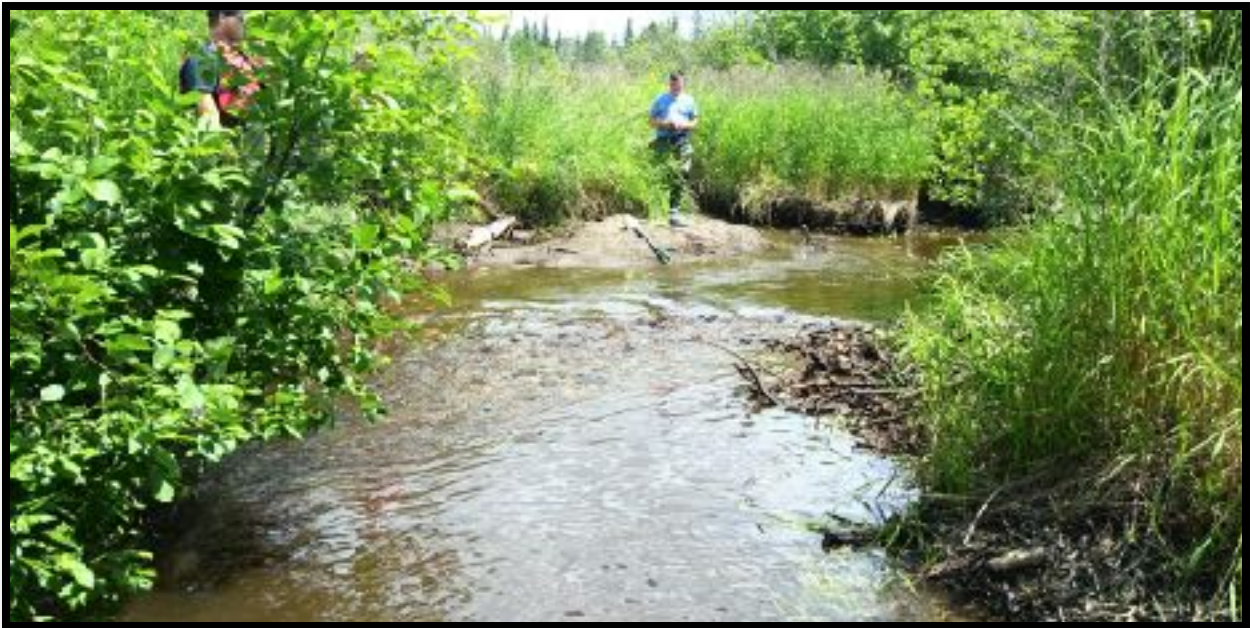
Dam site # 2

Water level above dam: 9 inches
Water level below dam: 5.5 inches

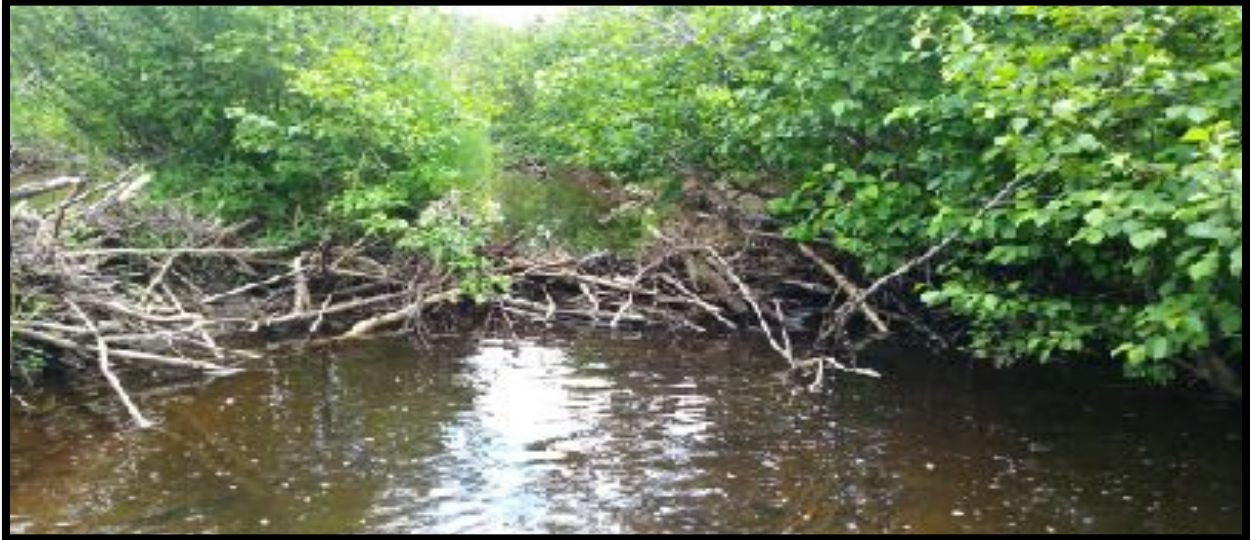
Dam site # 2 removed

Water level above dam: 21 inches, Water level below dam: 14 inches

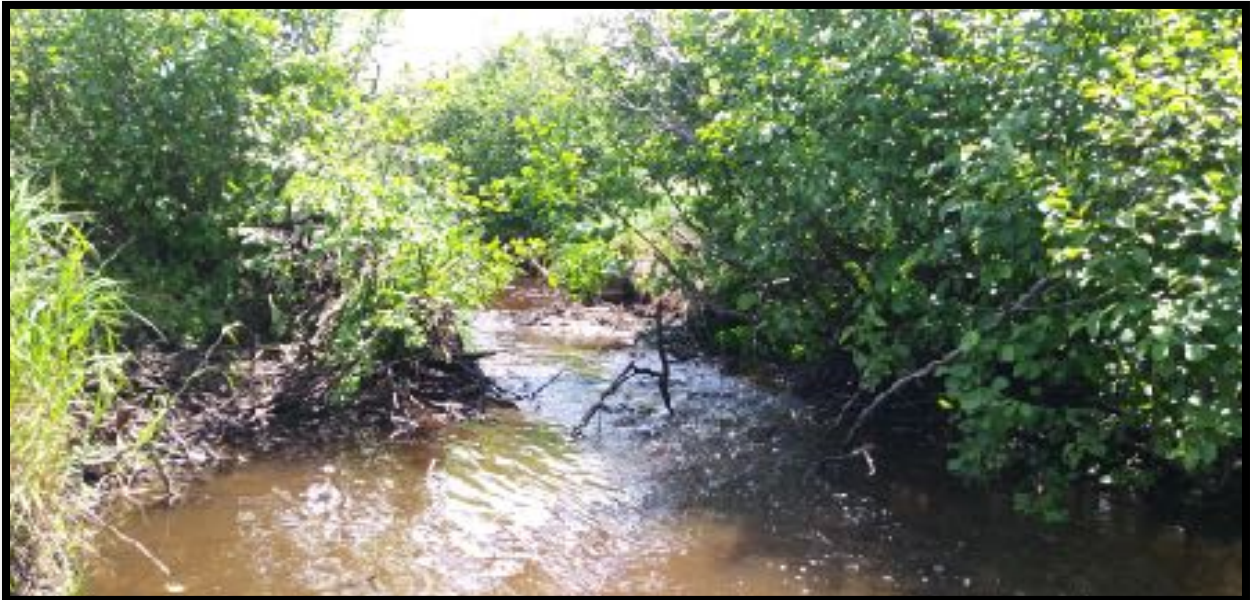
Dam site # 3.

GPS location 47.53352, -65.78954

Length of dam: 25 feet
Height of dam (left bank): 3.8 feet
Height of dam (right bank): 3.6 feet
Water level above dam: 3.3 feet, Water level below dam: 1 foot

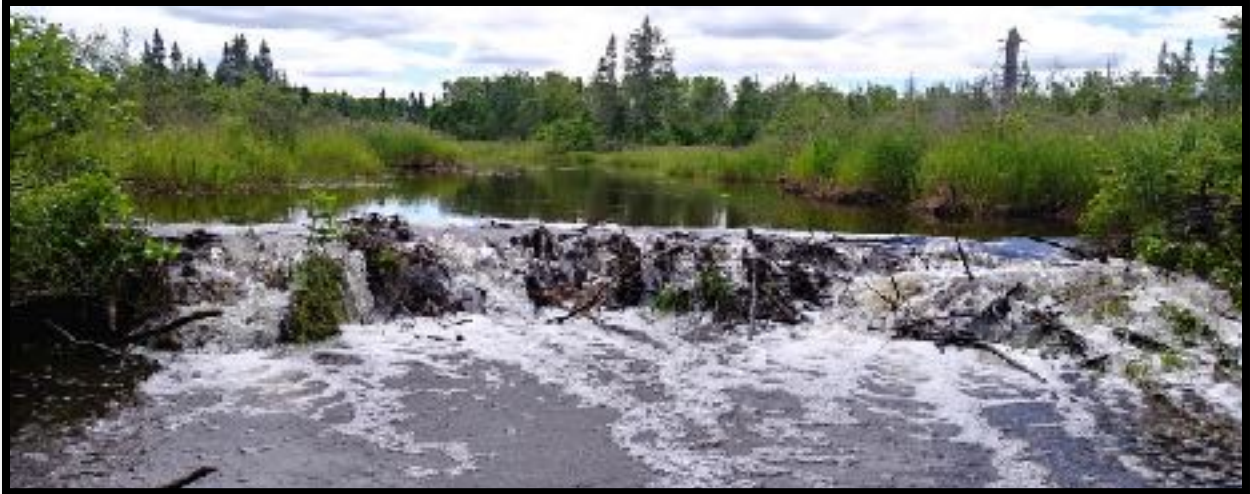
Another 4 inches removed from Dam site # 3 in July
Went back after weekend and the dam was restored by beavers. This dam is “officially” an active dam.

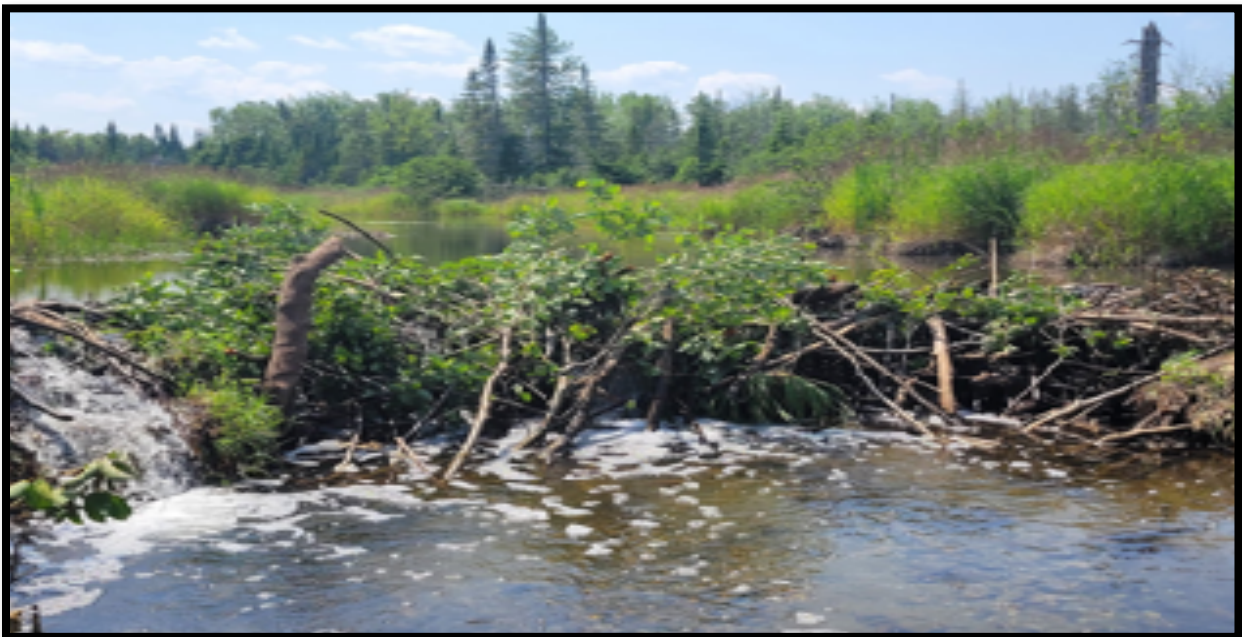
See restored dam picture below:

Nuisance control operator finished Little River trapping beaver contract on August 10, 2022. AFSAR team went to dismantled dam site # 3 once we got the go-ahead from Bruno Lebouthillier.

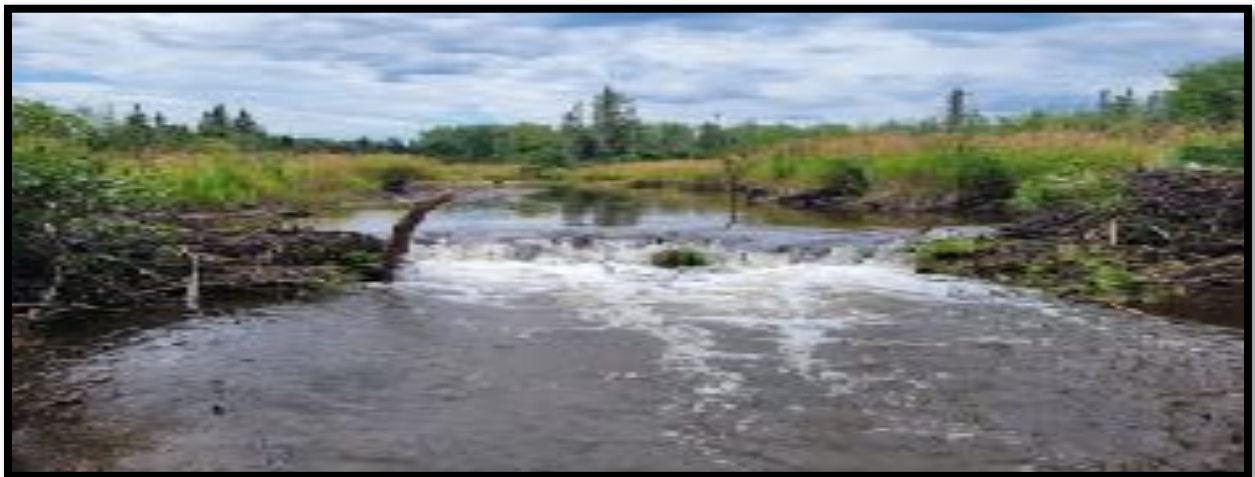
Water level before breach above dam: 1 foot, 6 inches

Water level before breach below dam: 1 foot, 3 inch

Beaver dam site # 3 completed.

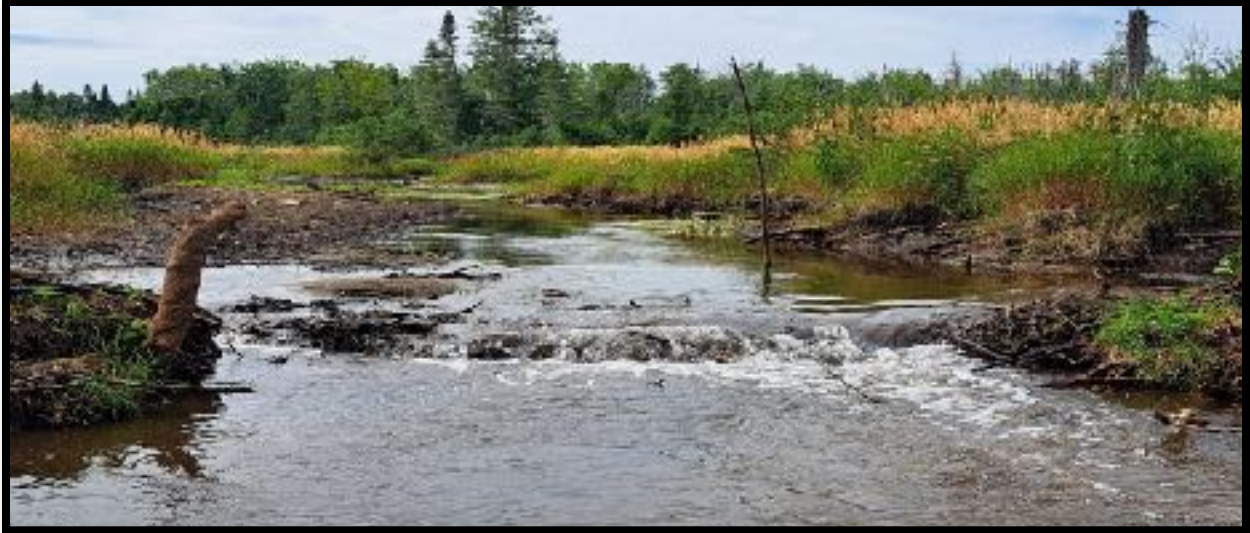
Water level above dam: 1 foot
Water level below dam: 1 foot

Debris from site # 3

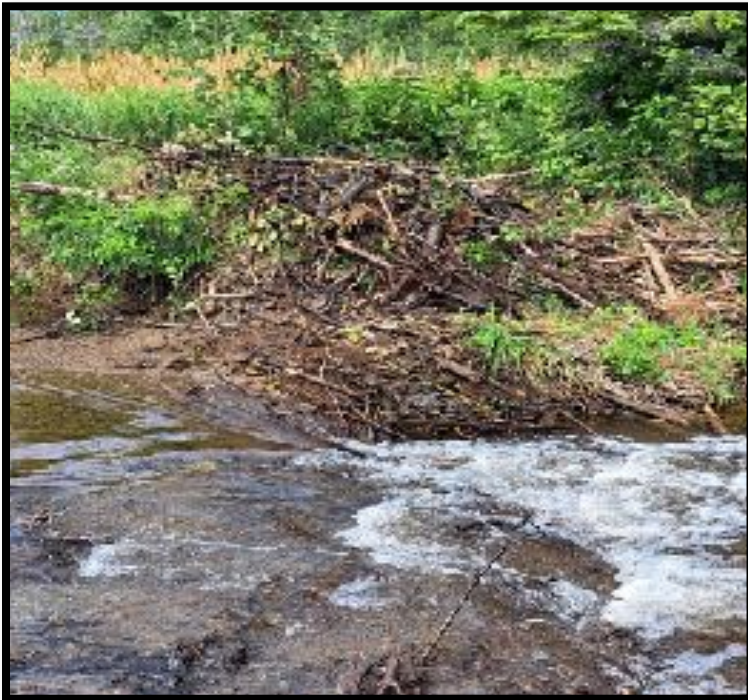
Dam site # 4.

Channel width: 19 feet

Height of dam (left bank): 3.5 feet
Height of dam (right bank): 4 feet

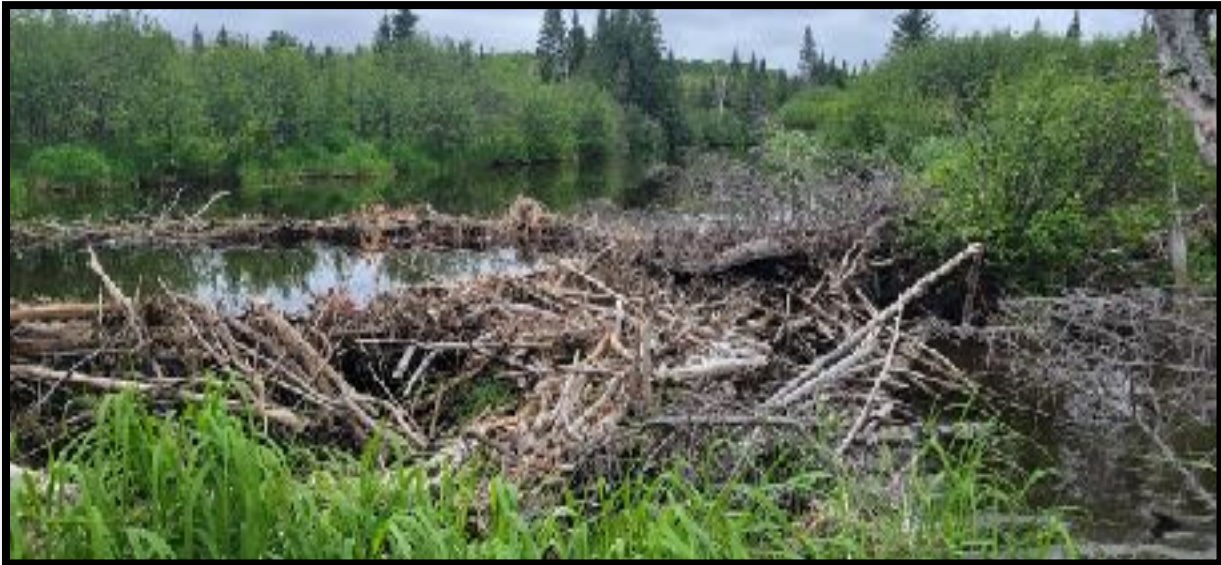
Dam site # 4 (back view)

Site # 4 is located 2 km downstream from North branch (NB) 4-Wheeler bridge 47.52556, -65.80389.

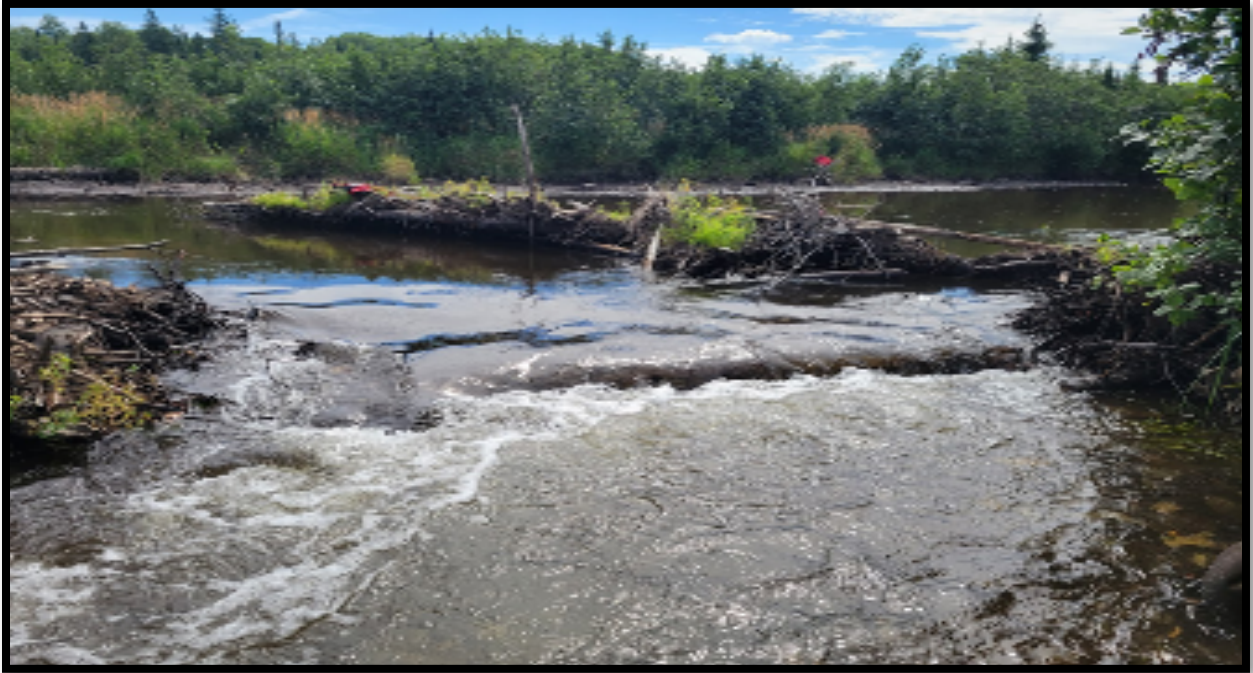
Dam site # 5,

GPS Location: 47.52623, -65.79588

Dam site # 5 (below dam)

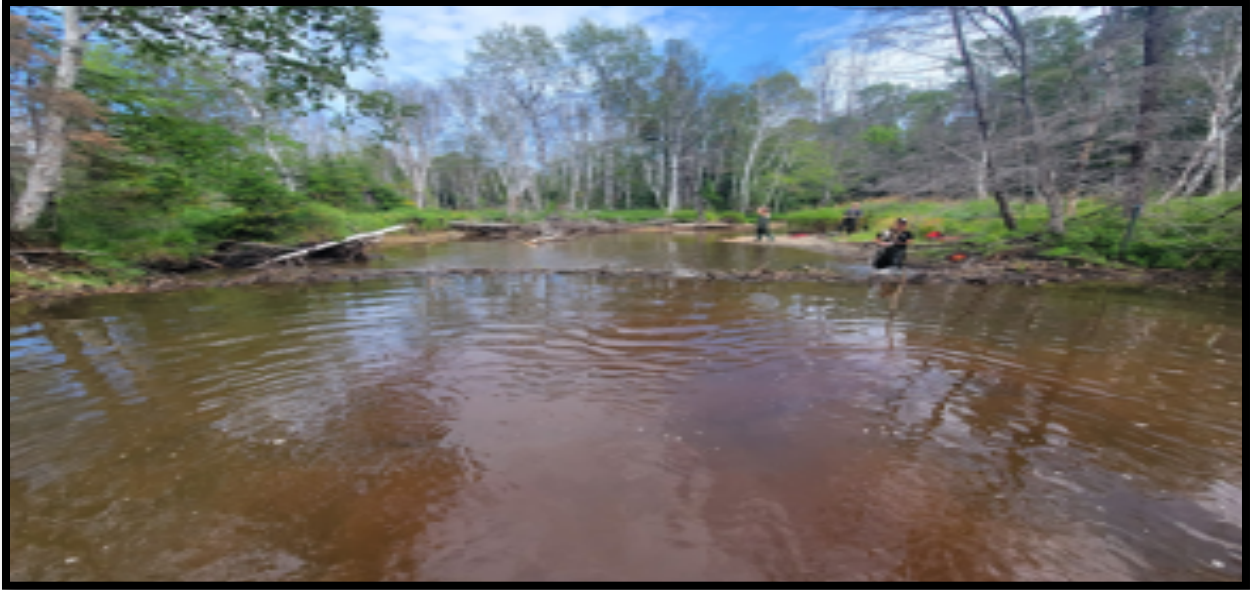
Picture of dam site # 5 completed.

Dam 5 water level above dam is 20 inches, and water below dam after breach is 14 inches.

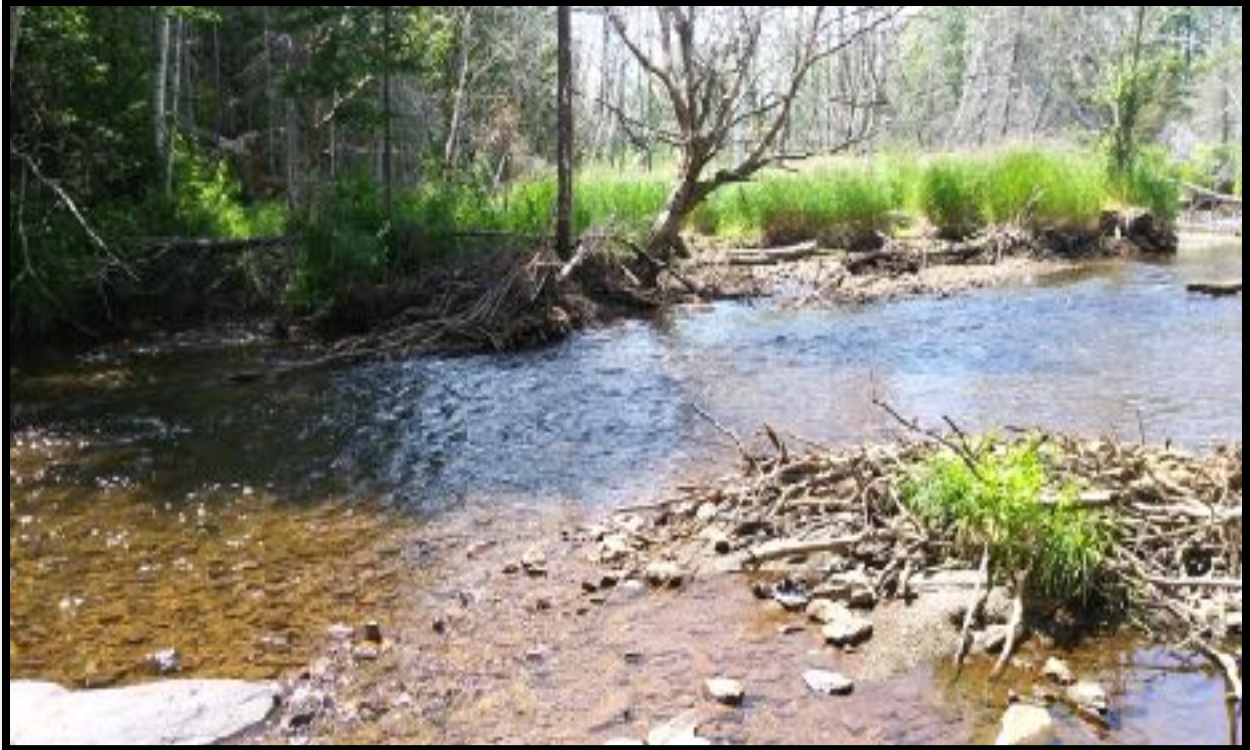
Also, there is a washed-out beaver dam approximately 20 meters down river from Dam site # 5. See picture below.

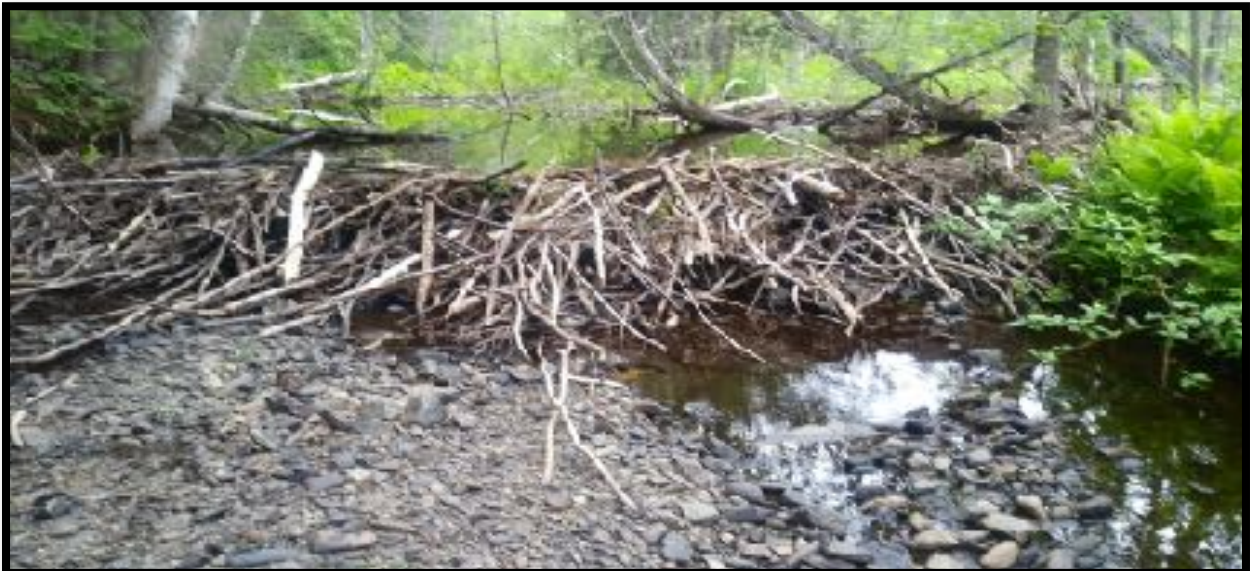
Water level above dam: 28 inches

Water level below dam: 3 inches

4 inches taken off dam site # 6

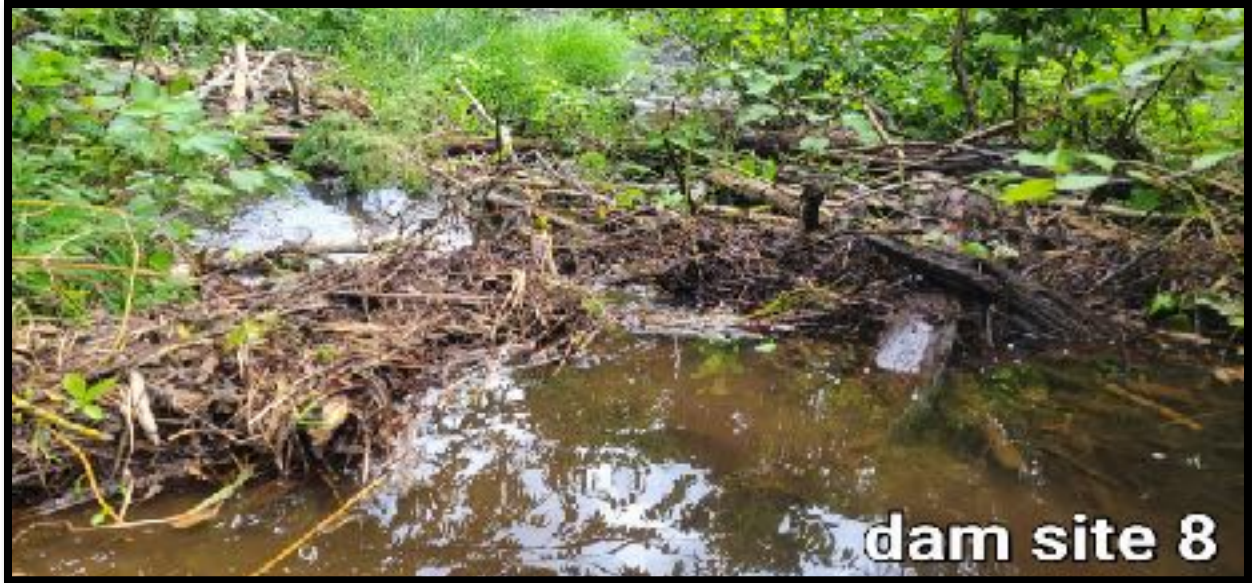
Dam site # 8

GPS location: 47.52686, -65.81730

Height of dam (left bank): 3.1 feet

Height of dam (right bank): 2.9 feet

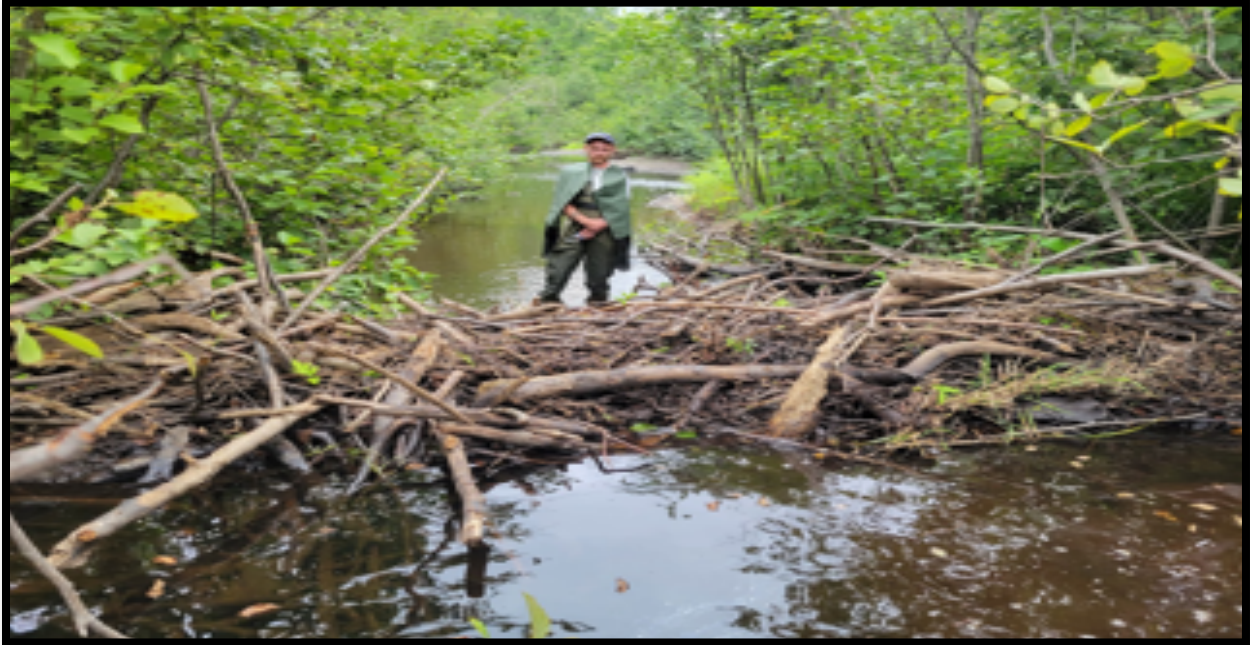
Dam site # 9

GPS location: 47.52683, -65.81751

Length of dam: 28 feet
Channel width: 20 feet
Height of dam (left bank): 3 feet
Height of dam (right bank): 2.5 feet

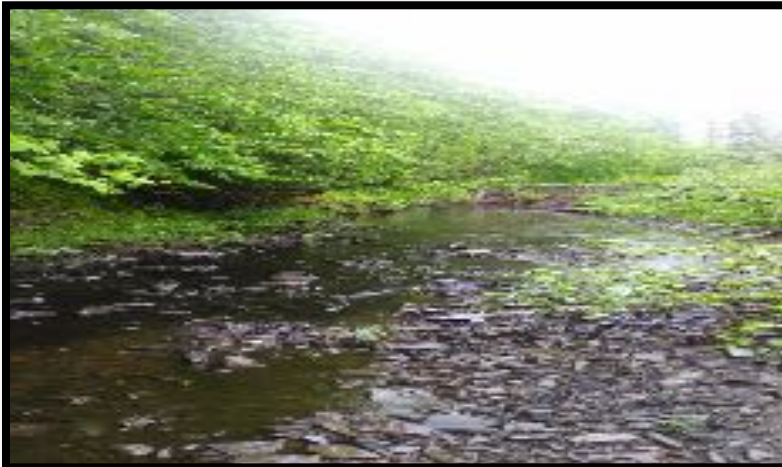
Dam site # 10

GPS location: 47.52687, -65.81782
Length of dam: 14 feet
Channel width: 12 feet
Height of dam (left bank): 2 feet
Height of dam (right bank): 2.5 feet
Dam was removed in early September.

Water level above dam: 12 inches
Water level below dam: 7 inches

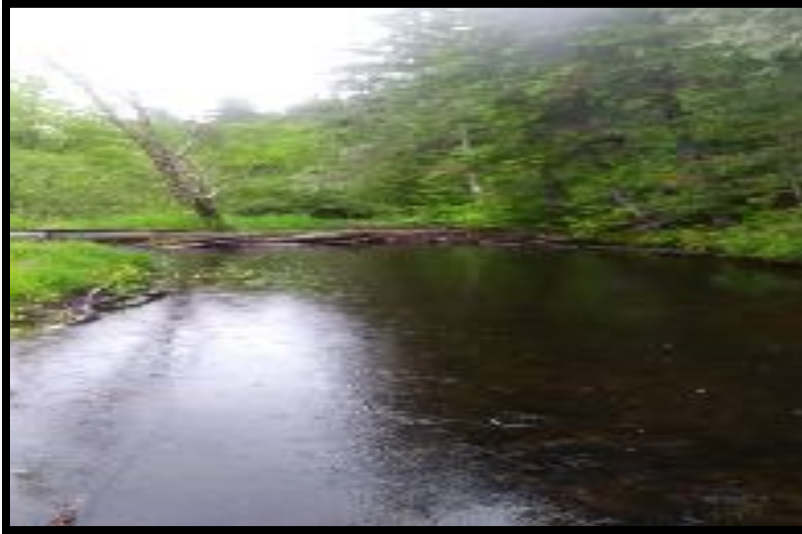
Dam site # 11

GPS location: 47.52635, -65.81805

Length of dam: 26 feet
Channel width: 22 feet
Height of dam (left bank): 3.3 feet
Height of dam (right bank): 3 feet
Dam was removed in mid-September.

Water level above dam: 14 inches
Water level below dam: 8 inches
