FISHERY PROGRAMS ANNUAL REPORT 2022

SALMON COUNTING FENCE ANNUAL REPORT 2022

Little River Water Quality Assessment 2022

LITTLE RIVER BRAVER DAM REMOVAL PROJECT 2022

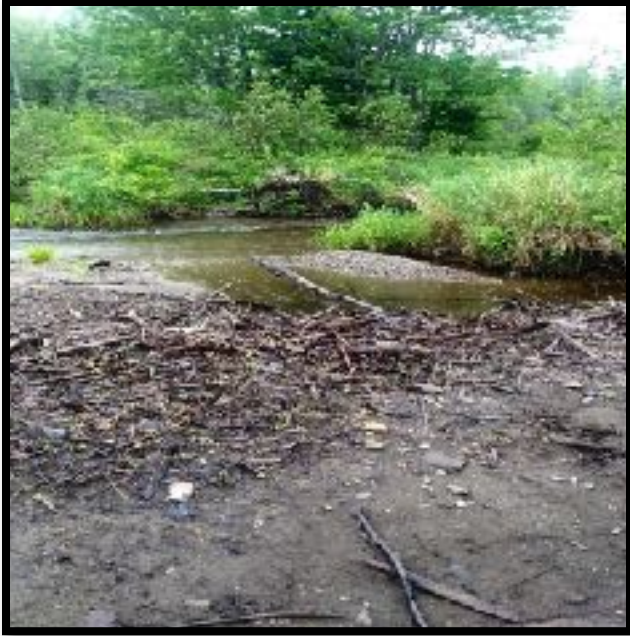
Dam site # 12

GPS location: 47.52604, -65.81915
Length of dam: 14 feet
Channel width: 12 feet
Height of dam (left bank): 2 feet
Height of dam (right bank): 2.5 feet
Dam was removed in mid-September.

Water level above dam: 12.5 inches
Water level below dam: 9.5 inches

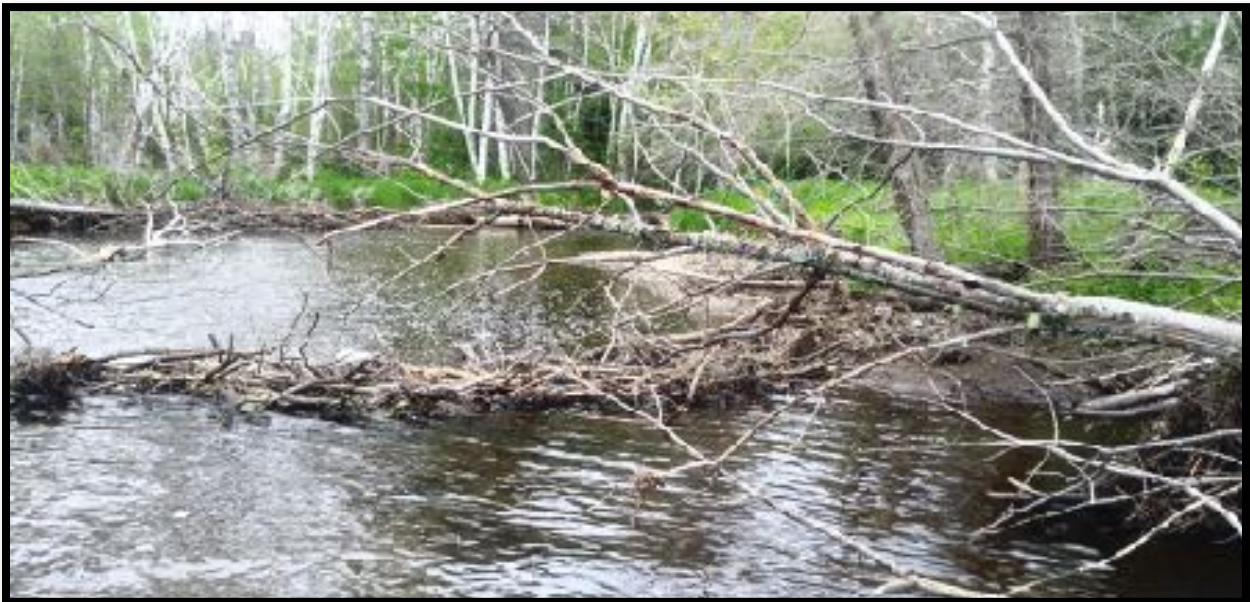
Dam site # 13

GPS location: 47.52589, -65.81873
Length of dam: 21 feet
Channel width: 16 feet
Height of dam (left bank): 2 feet
Height of dam (right bank): 2.5 feet
Dam was removed in late September.

A total of 19 beaver were removed by nuisance control operator during the project and 13 beaver dams were dismantled by the Fish Obstruction Monitoring Technicians. However, other beavers started to move in the watershed and by the end of September/early October new beaver dams are being built. Due to federal/provincial law, beaver dams cannot be removed/dismantled from October 1 to May 30; therefore, the Fish Obstruction Monitoring Technicians did not remove any dams after the end of September 2022. However, Pabineau First Nation Fish Obstruction Monitoring Technicians will continue the beaver dam removal work in the Little River watershed in 2023.
